Country report Belgium RROG 2019, Mainz

Reactor core performance of BR2

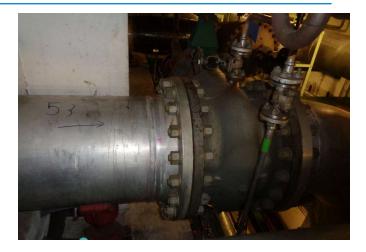
Primary loop inspections

- Indication of non acceptable defect in circumferential pipe to flange weld
 - Section at redundant primary pump taken out of service – no safety impact; operation with 3 primary pumps during cycle 03/2018
 - Pipe section replaced by stainless steel section during shut-down 04/2019
 - Designed according to ASME VIII code
 - New sealing material qualified with sufficient gamma dose margin
- Post extraction analysis:
 - No defect present (X-ray), UT indication due to weld repair (not documented)
